# A Complex Treatment Solution Is on the Menu

New owners of a popular Georgia seafood restaurant require clean effluent and 2,500 feet of dripline to open for business

## System Profile

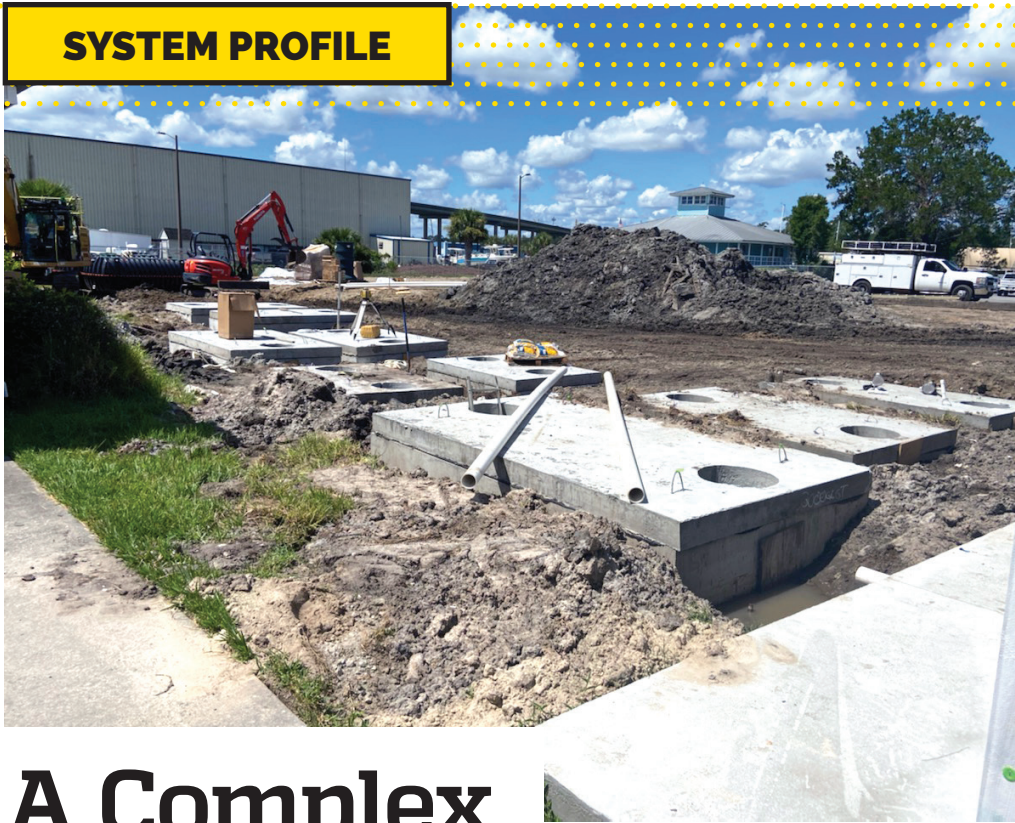
◀ An overview of the layout after precast tanks were set and lids placed. Also pictured, is a pile of the decomposed garbage muck that was removed to make room for the tanks.

"The restaurant actually sits on an old landfill that was used in the 1930s and '40s," Blaney says. "When I started digging, I hit a layer of decomposed garbage and glass bottles. I ended up hauling out 19 full dump truck loads of garbage muck."

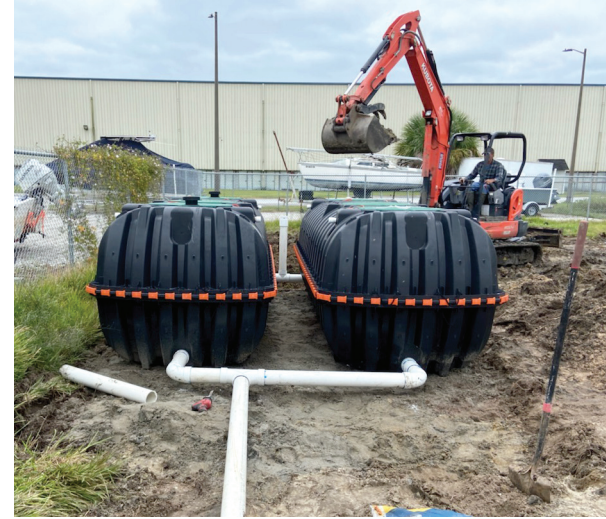
▼ Installer Scott Blaney backfills around the plumbed-in Anua BioCair filters using his Kubota mini-excavator.

After aeration, water flows to a 2,000-gallon clarifier tank where it is pumped into two Anua model 1530 BioCoir coconut fiber biofilters for further treatment ensuring clean discharge. Following the BioCoir filters, water flows via gravity into a precast concrete distribution box.

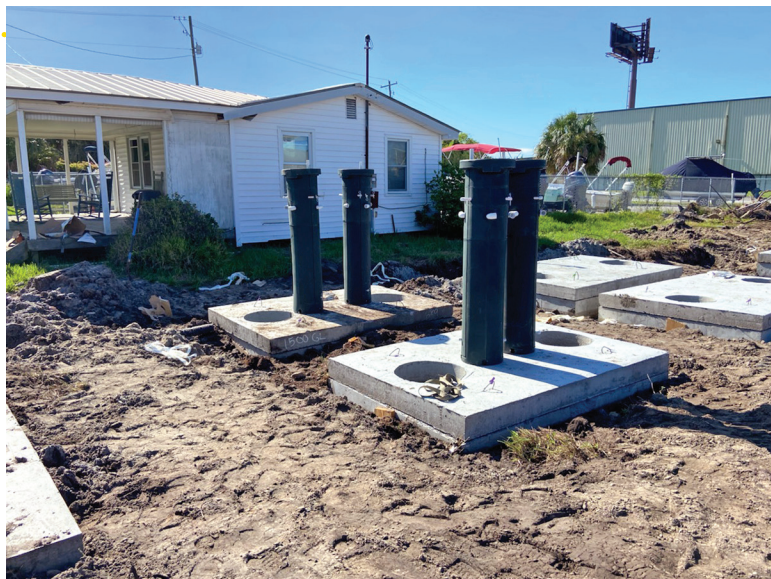
◀◀ The Anua PuraACE reactor pods getting prepped before installation in the aeration tanks.

aeration tanks. Inside each aeration tank are two PuraACE (Anua) reactor pods for additional treatment of wastewater.

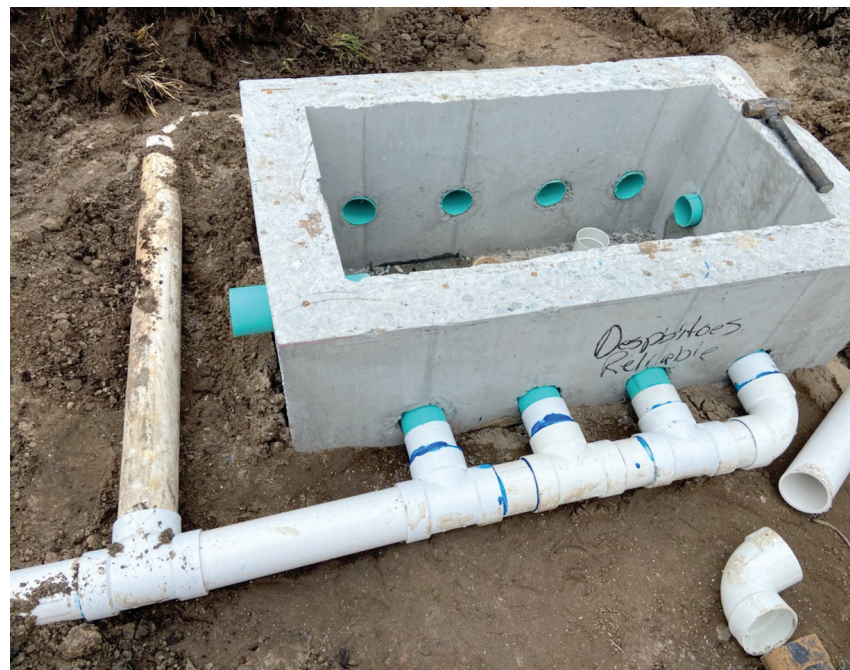
▼ The distribution box during plumbing.

"The D-box sends 20% of the water over to two more distribution tanks," Blaney says. "The remaining 80% goes through an Anua Puralinity pH Biobuffer and from there, it reenters the system in the clarifier tank."

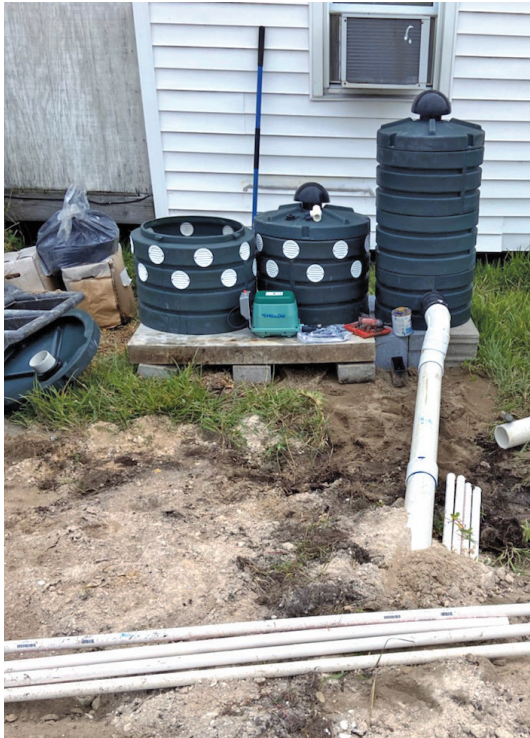
▲ The Anua Puralinity pH Biobuffer set and ready to be plumbed (far right).
